Vehicle Identification / Recognition

Applicable to Tucson Plug-in Hybrid vehicles first sold in the United States.	ID. No.	Version No.	Page
	KMH-NX4 PHEV	01.2021.09	2 of 2

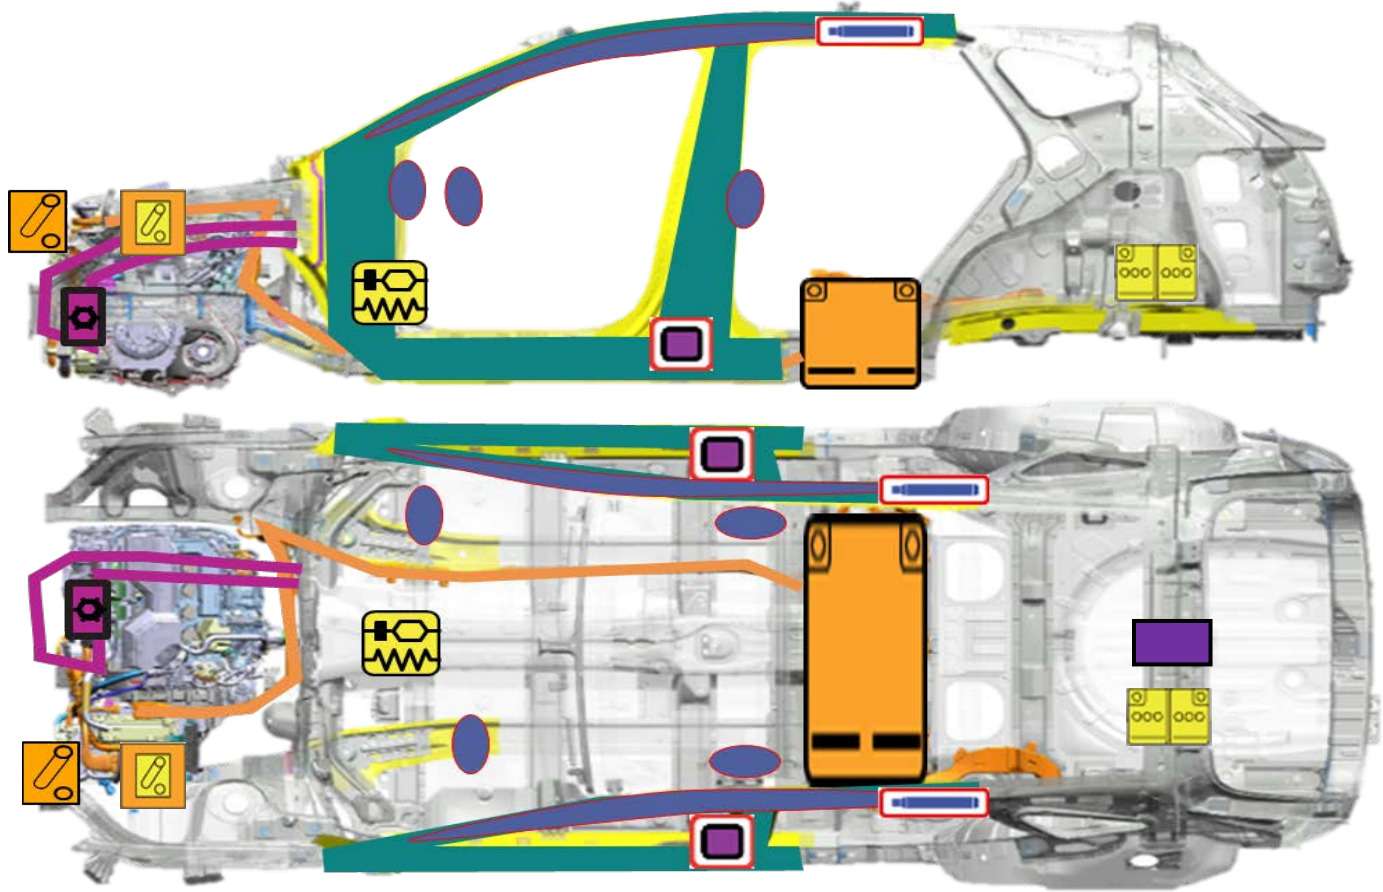
Accessing Vehicle

Supplemental Restraint System Control Module (SRSCM)

Airbag

Airbag Gas Inflators

High voltage cable

12 Volt Battery

Air-conditioning line

Low voltage disconnect for high voltage

OBC (On – Board Charger)

Ultra-High Strength Steel

High Voltage Battery

Air-conditioning component

Seat belt pretensioner
